NASA TM X-2732

TESTING OF URANIUM NITRIDE FUEL  
IN T-111 CLADDING AT 1200 K  
CLADDING TEMPERATURE

*by Robert G. Rohal, Thomas N. Tambling,  
and Roger L. Smith*

*Lewis Research Center  
Cleveland, Ohio 44135*

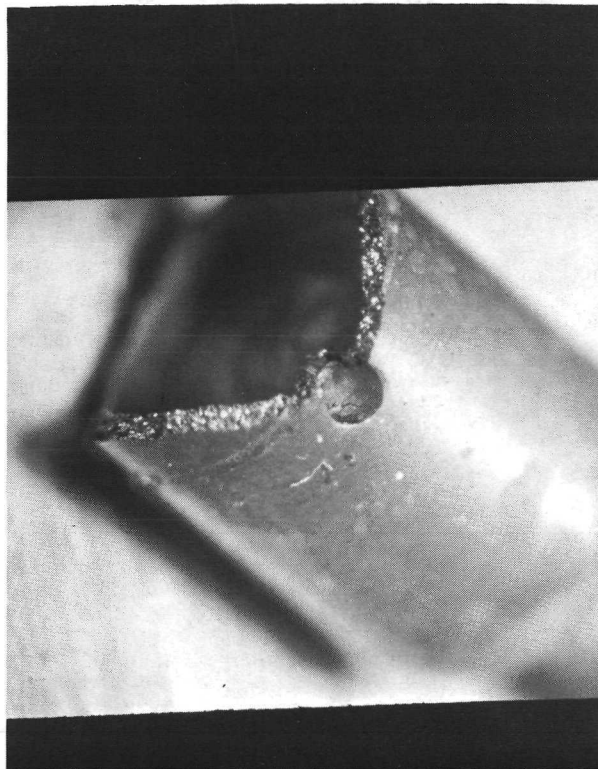
(b) End cap of fuel pin after point impact.

The fuel pins were then subjected to an examination to determine the extent of fission gas release from the fuel. This was done by placing the fuel pins in a sealed volume container, puncturing the clad tube with a sharp punch-type device, and then recording the pressure rise in the container. However, in the first group of capsules, the clad which was initially ductile underwent a brittle fracture upon impact from the sharp punch. Figure 7(b) shows one end cap of a fuel pin of the first group after such an impact.

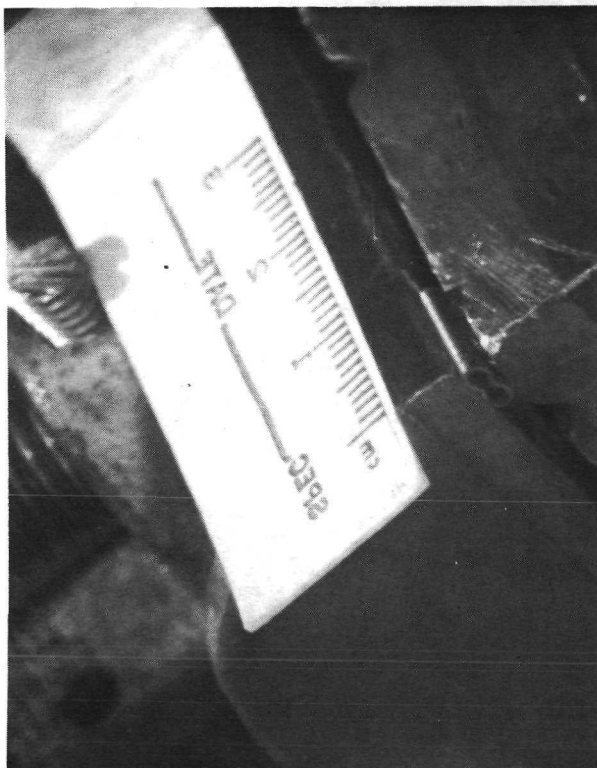
Two rings were cut from the clad tube of fuel pin 322B in exactly the same way as was done for fuel pin 321D. The first ring was placed in a vise and compressed. This ring could be compressed to about one-half its diameter before any cracking was observed. Further compression produced cracks in the ring. The progress of this ring compression test is shown in figure 9. This compression indicated that the clad of fuel pin 322B was significantly more ductile than the clad of fuel pin 321D. The second ring from 322B was vacuum annealed at 1311 K (2360° R) for 1 hour. The ring was compressed in a vise; the results of this compression indicated that the ductility of the ring was fully restored.

Figure 9. - Progression of compression test of ring from fuel pin 322B.

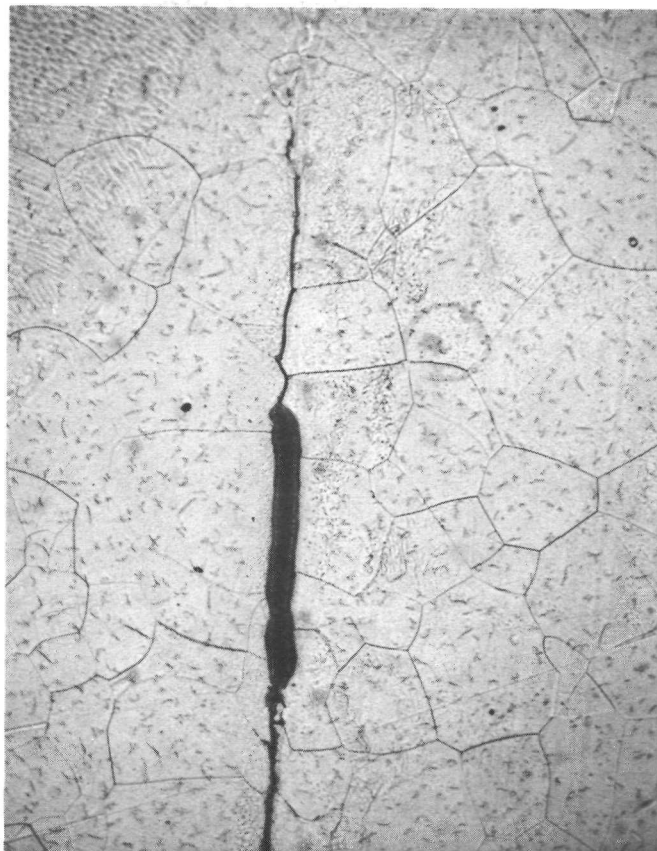
In accordance with usual hot laboratory procedure, samples of the T-111 clad were polished and etched. The photomicrographs did not reveal any unusual formations in the clad material. A typical photomicrograph is shown in figure 10.

Figure 10. - Photomicrograph of a section of T-111 clad (fuel pin 321B at X250).

The postirradiation examination data obtained and discussed herein do not conclusively indicate the reason for the cladding embrittlement. However, the fact that the photomicrographs did not reveal any unusual formations seems to indicate that the embrittlement was most likely caused by nitrogen, oxygen, or hydrogen. This also indicates that the braze material on the first group of pins was not the reason for their embrittlement. Oxygen and nitrogen were virtually eliminated as the source of embrittlement. The reason for this is that the ductility of the T-111 was restored with vacuum anneals at temperatures too low to drive out the oxygen or nitrogen from the T-111. The results of the Kjeldahl analysis verified that nitrogen was not the cause for embrittlement of the T-111. Thus, we believe that hydrogen caused the embrittlement. This is confirmed to some degree when comparing the results of the ring compression tests for the first and second group of fuel pins. The clad of the second group of fuel pins was more ductile. These fuel pins were assembled in a way to minimize the amount of contamination by hydrogen and oxygen by eliminating as much water vapor from the capsule as possible.
